Inhome Property Solutions

Property Survey

144 Rugby Road

We have attended the property to investigate the issues relating to mould and damp throughout the property.

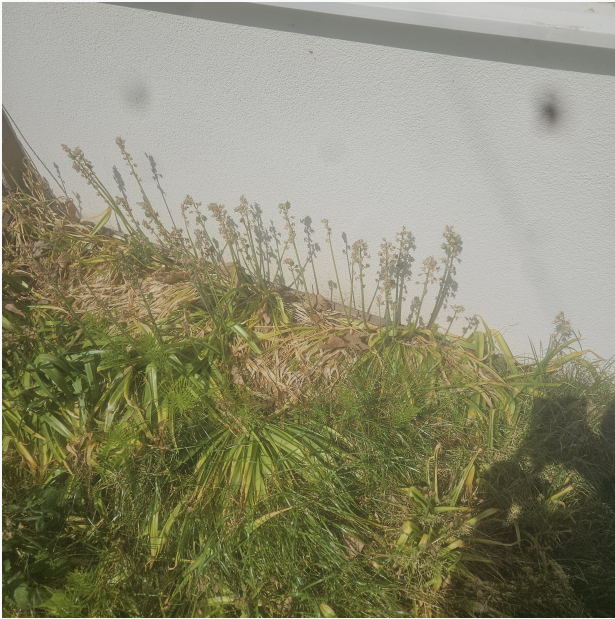
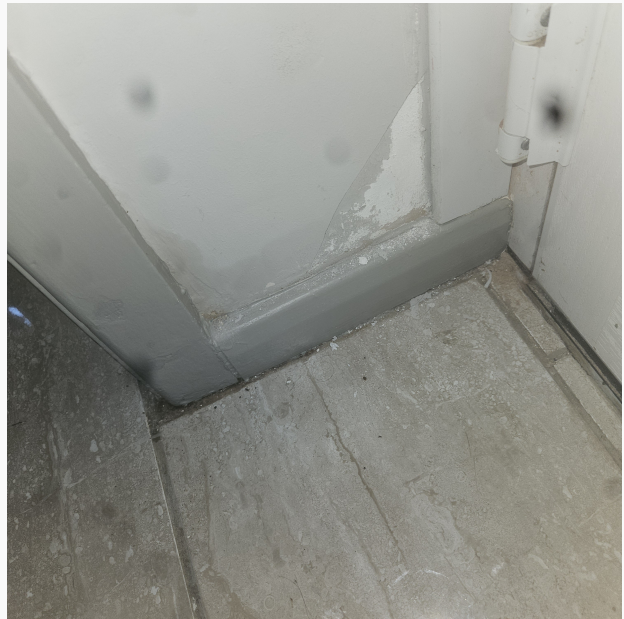
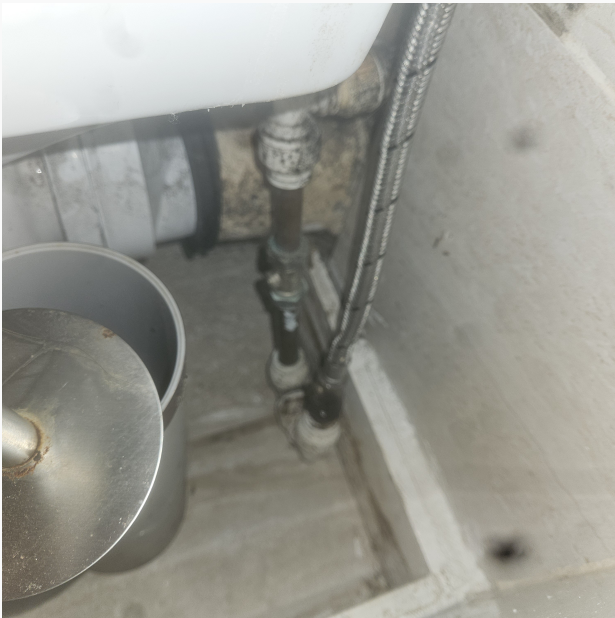
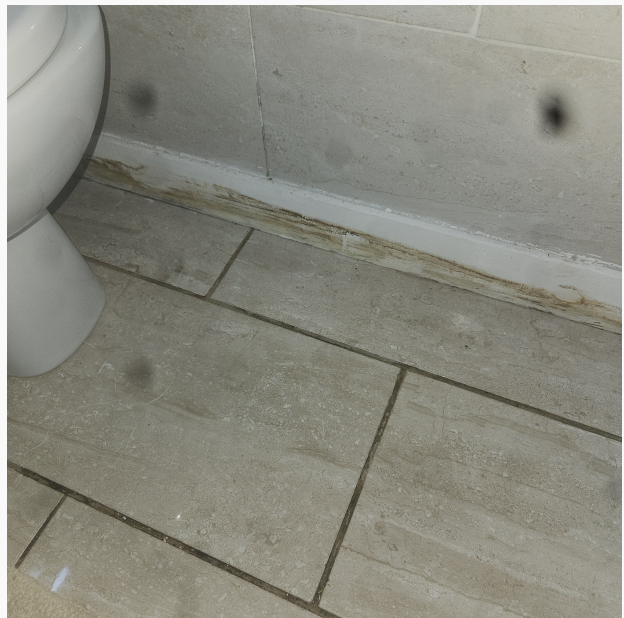
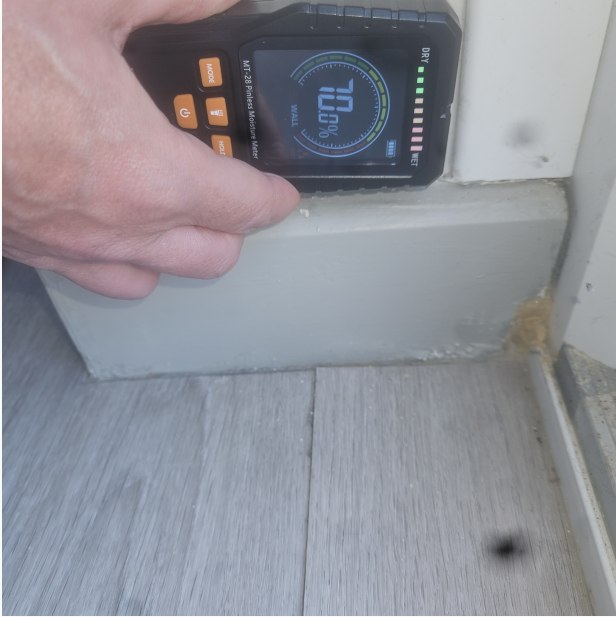
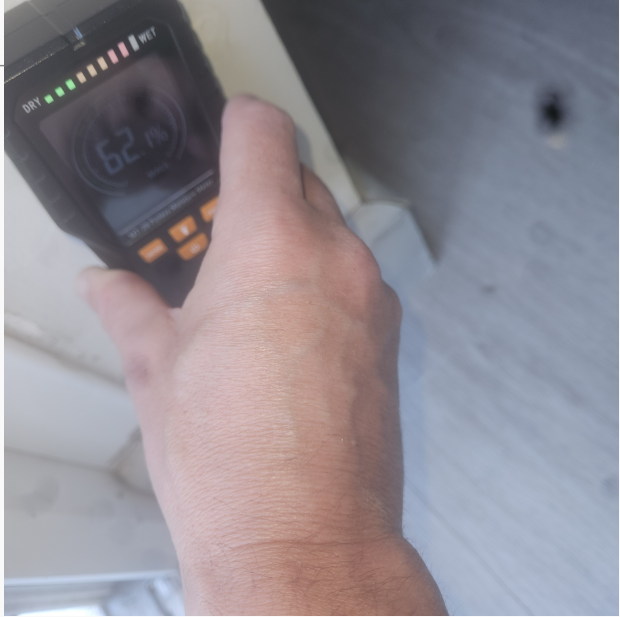
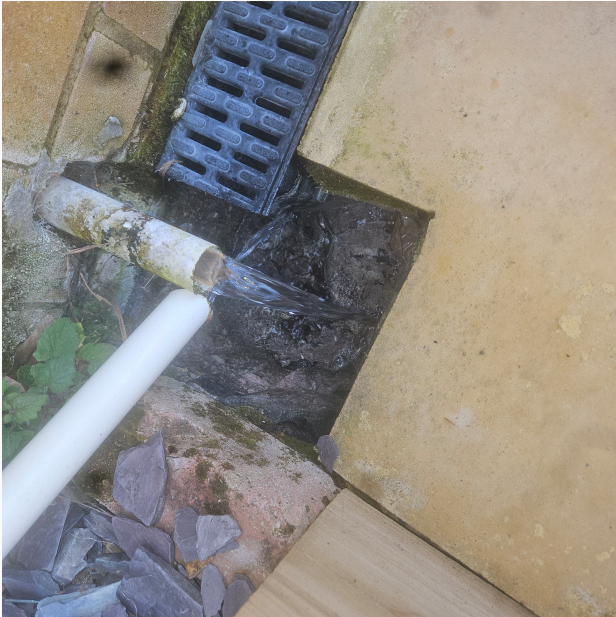
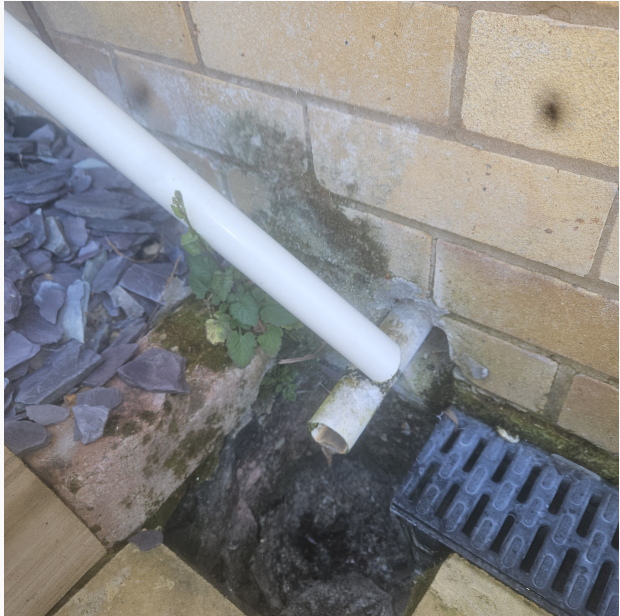
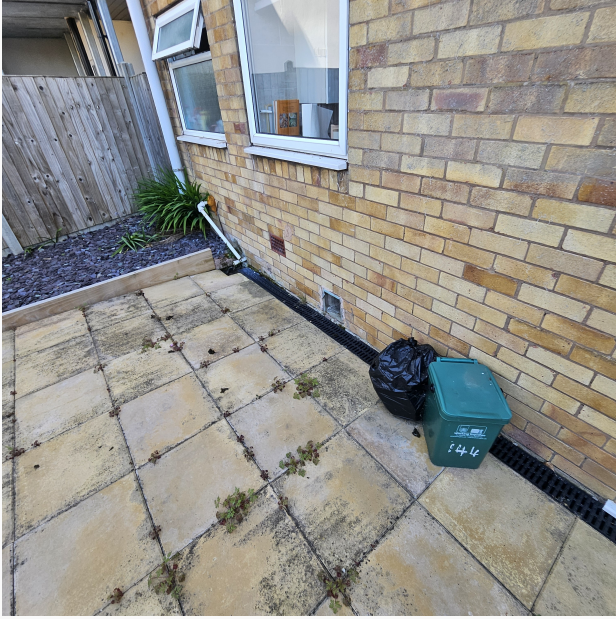
Photos

Upon inspection within the bathroom, we found that the toilet appears to be leaking from around the isolation valves/pipework area. This appears to be a constant leak, which is allowing water to track into the skirting boards and surrounding wall areas. Visible water damage can clearly be seen to the skirting, and moisture is also finding its way through towards the front door area and adjacent skirting boards.

We also identified movement within a number of the bathroom floor tiles, which would suggest that water may have penetrated beneath the tiled floor area. At present, we cannot fully confirm the extent of any damage beneath the floor without further intrusive investigation, however this is something that should be monitored moving forward.

Externally, to the rear of the property, there is an ACO drainage channel which leads into the main drain. Upon inspection, the main drain was found to be heavily blocked with debris, dirt and general build-up, preventing water from flowing away correctly. We created a temporary opening within the blockage to allow some wastewater to flow through, however the drain requires proper attention. Evidence of standing/rising water could also be seen externally around this area.

To the front of the property, there is also a substantial area of overgrown grass/vegetation which does not appear to have been regularly maintained. This can retain moisture against the property and may also be contributing towards dampness within lower wall areas. We would therefore recommend that a gardener or maintenance contractor attends to clear back and maintain this area to prevent moisture continually sitting against the external walls.

- Attend with a drainage team to fully jet and clear both the main drain and ACO drainage system to ensure wastewater can freely flow away correctly.
- Attend with a plumber to carry out repairs to the leaking toilet pipework/isolating valves.
- Remove, clean, treat and redecorate the affected skirting boards and wall areas once fully dry.
- Clear and maintain the overgrown external vegetation/grass areas to reduce retained moisture against the property.
