Inhome Property Solutions

# Property Survey

155 Sycamore Road Smethwick B66 4NS

Mould and Damp Investigation Report

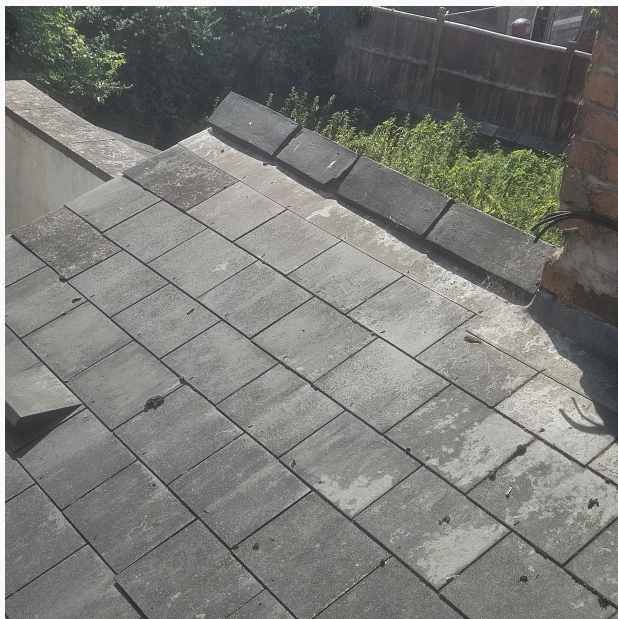
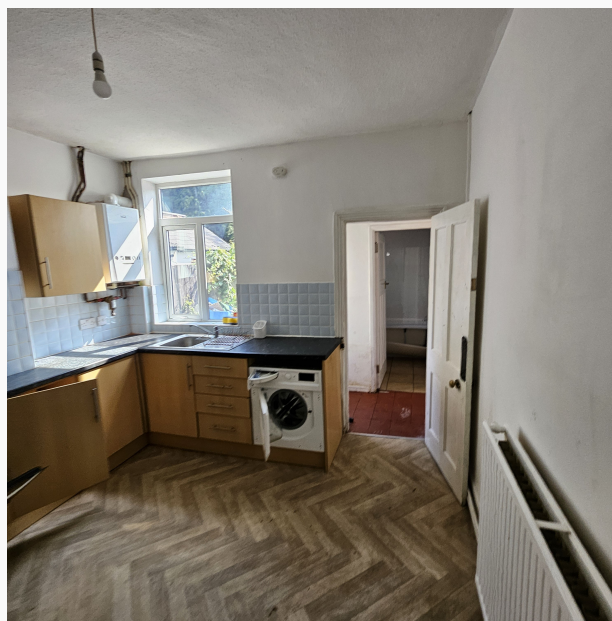
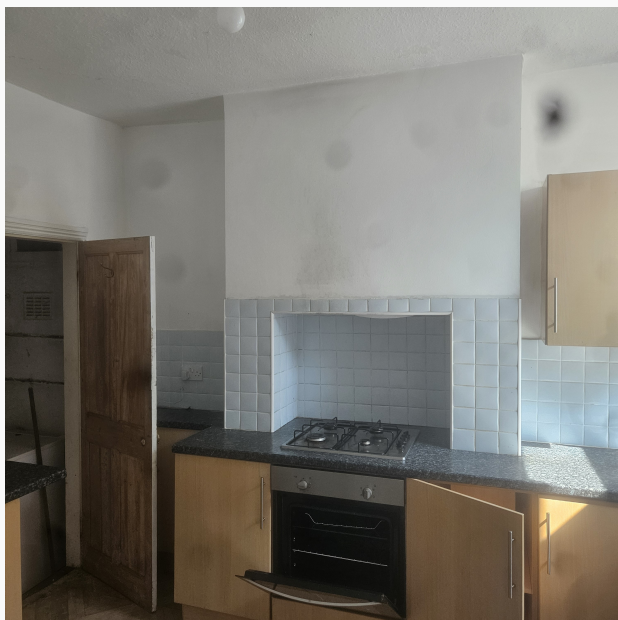
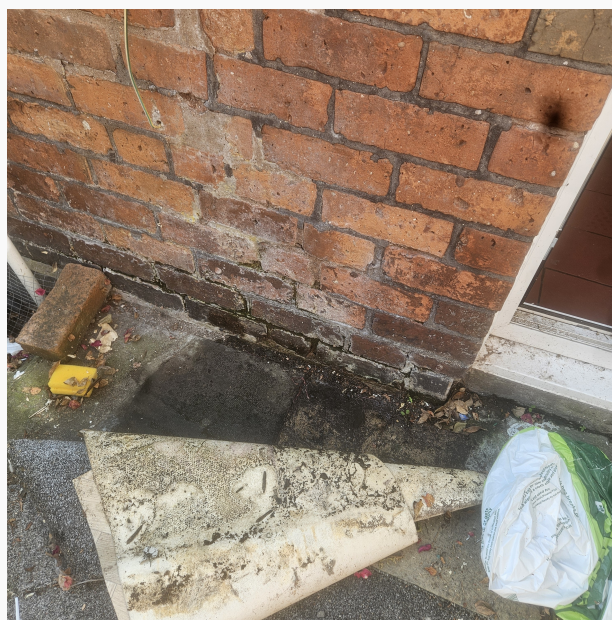
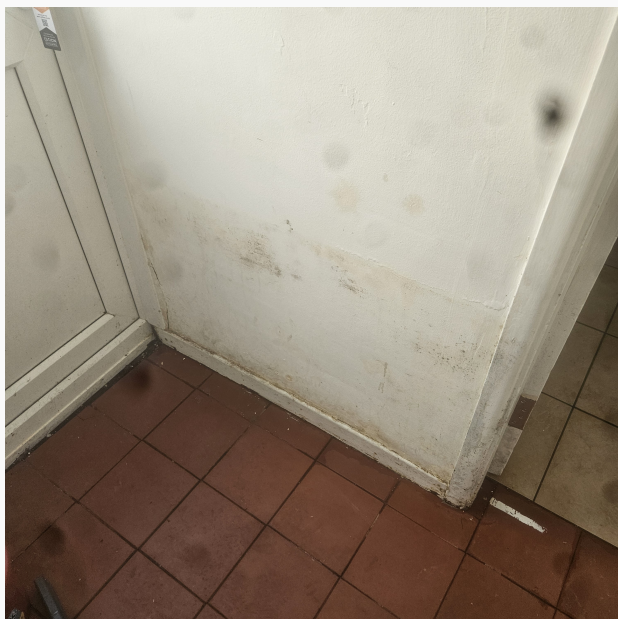
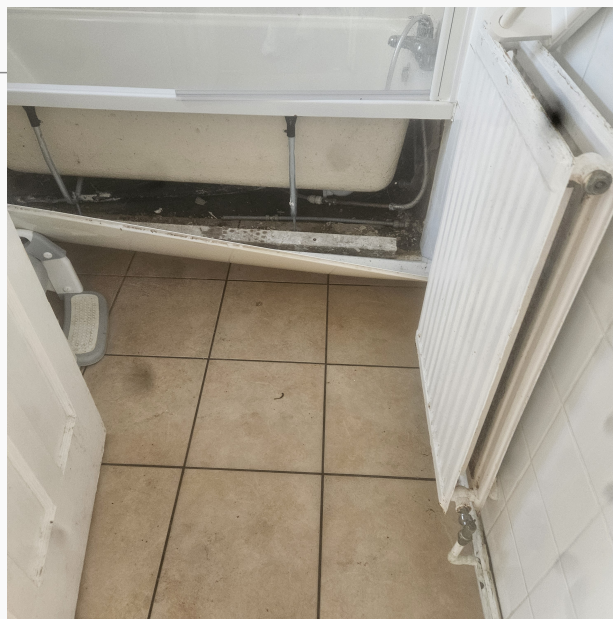
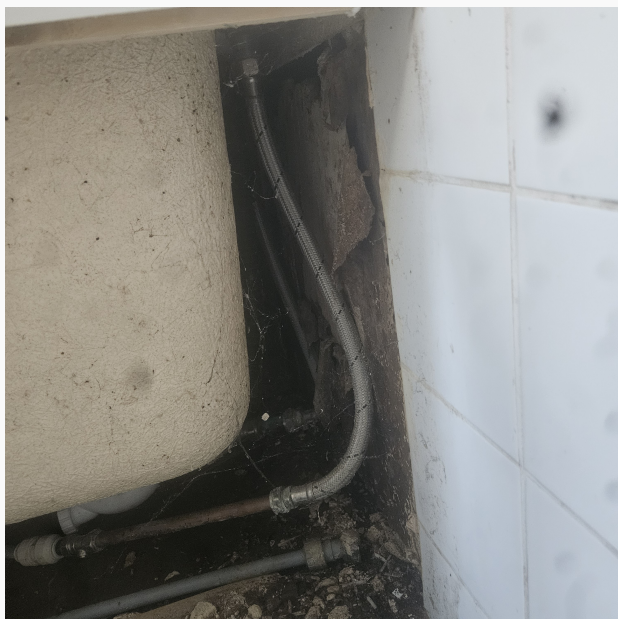
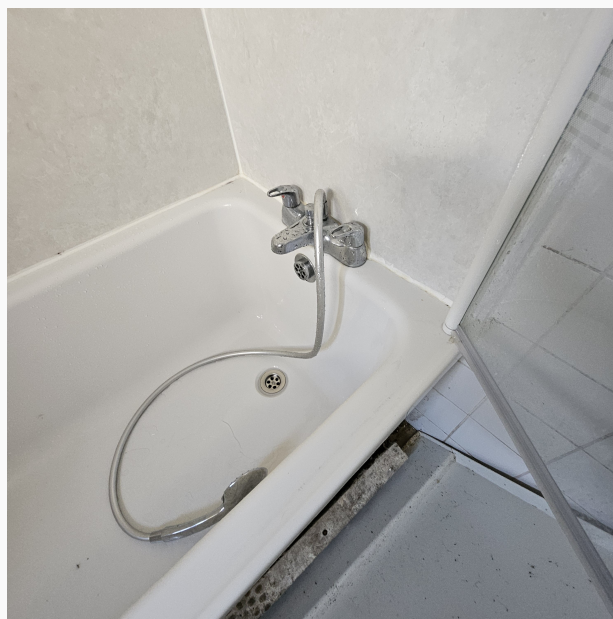
Upon entering the property, a large wet patch was evident on the internal wall adjacent to the bathroom. On entering the bathroom, standing water was present on the floor.

The bath panel was then removed, and the bath taps were run during testing. It was evident that water was running down the wall behind the bath while the taps were in use. This water is escaping behind the bath, saturating the wall and surrounding structure before finding its way beneath the bath and eventually penetrating through into the adjoining wall. This is the primary cause of the damp staining and moisture build-up identified internally.

As shown in the photographs, the area beneath the bath is heavily saturated with clear signs of prolonged moisture exposure.

An external inspection of the extension roof directly above the affected bathroom identified that the ridge tiles have almost completely lost their mortar bedding. Large sections of mortar are missing, allowing rainwater to penetrate directly beneath the ridge tiles during wet weather. This provides a further route for water ingress into the bathroom below.

The external brickwork adjacent to the affected area also requires repointing. Mortar joints have deteriorated significantly, allowing moisture to penetrate into the masonry and contribute to the dampness affecting the internal wall.

Replace the defective bath taps to eliminate the water leak behind the bath.

Re-bed all ridge tiles on the extension roof using new mortar.

Repoint the external brickwork adjacent to the affected wall.

Supply and install humidistat-controlled extractor fans to both the kitchen and bathroom.

Carry out mould remediation to the affected kitchen areas once the sources of moisture have been eliminated.
