Property Survey

93 Lowther Street Coventry CV2 4GL

We have attended the property today to investigate the issues of mould and damp.

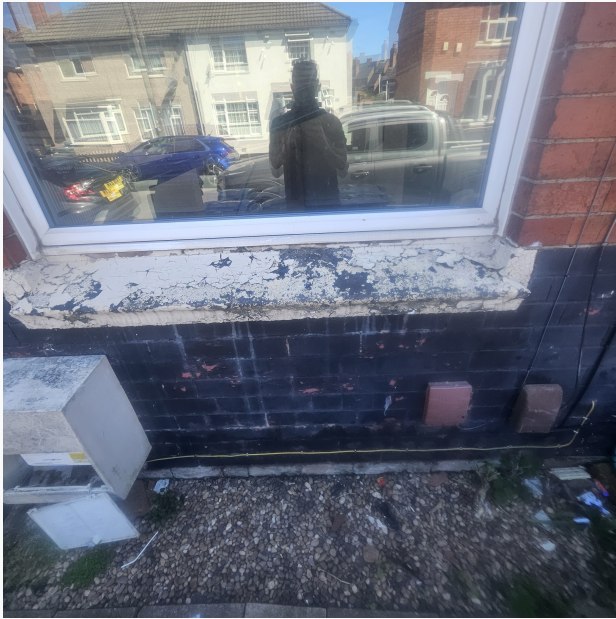
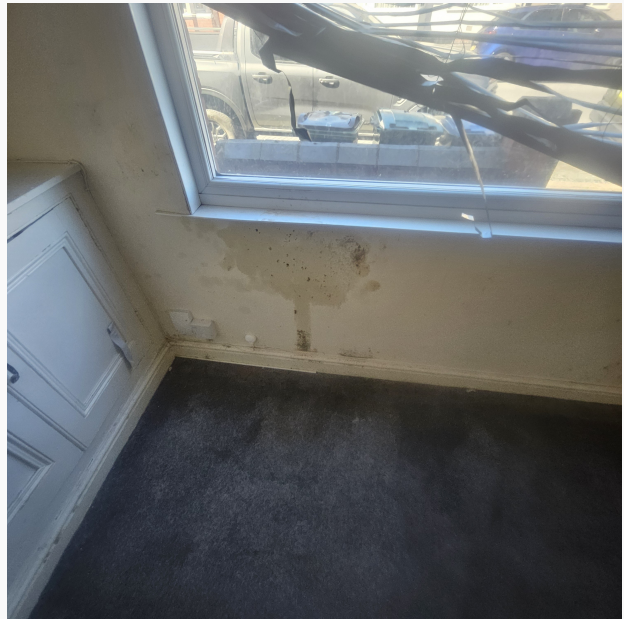
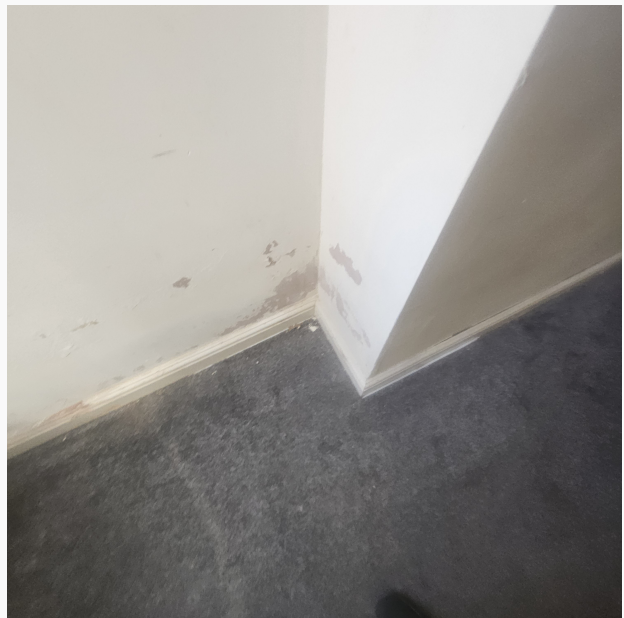
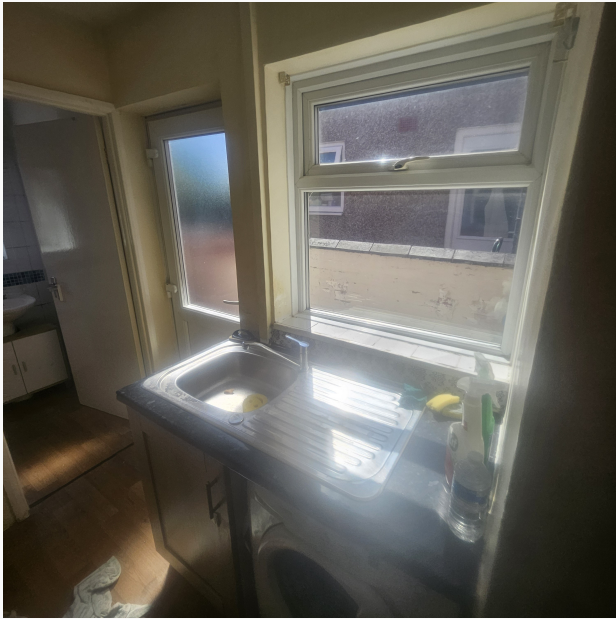
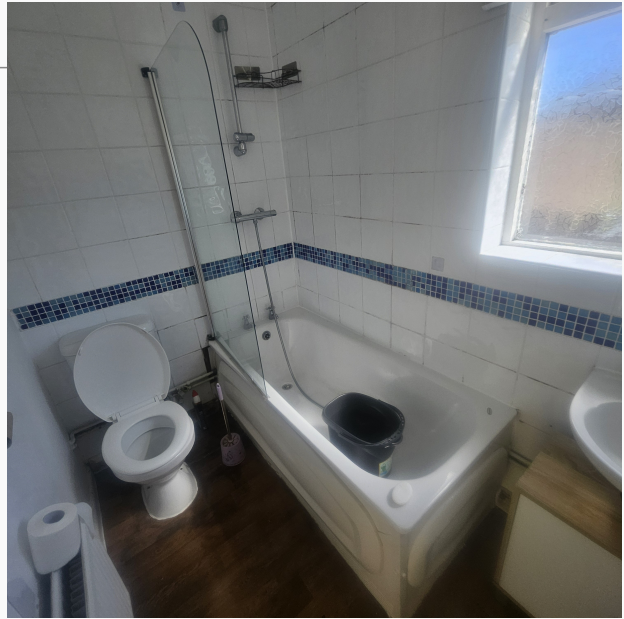
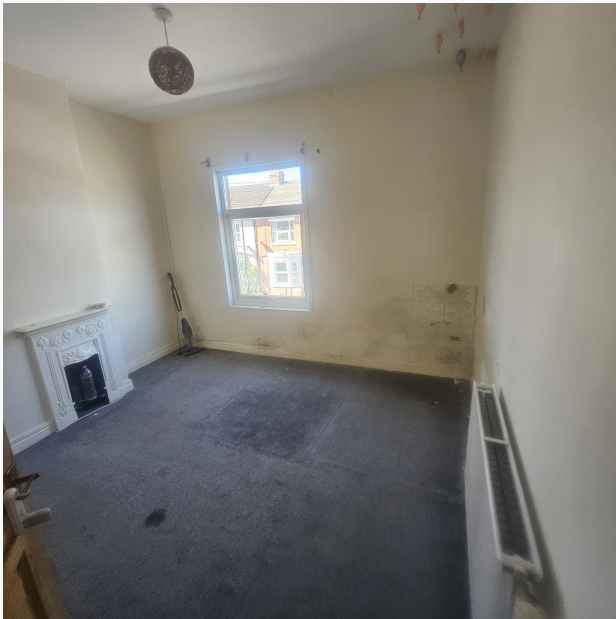
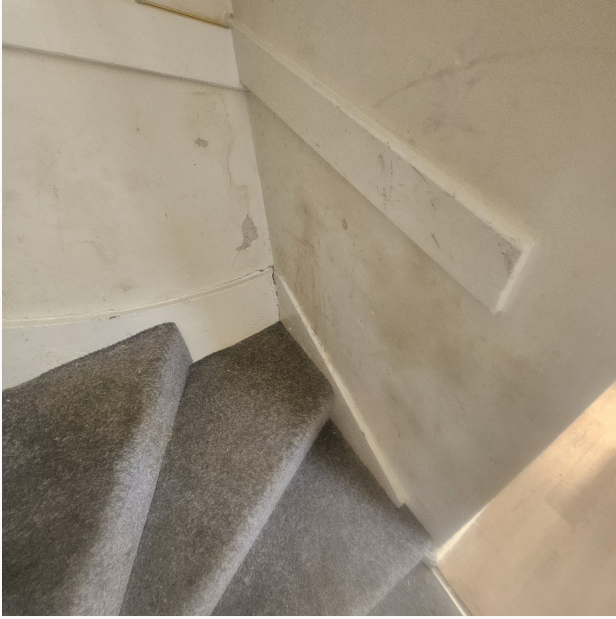
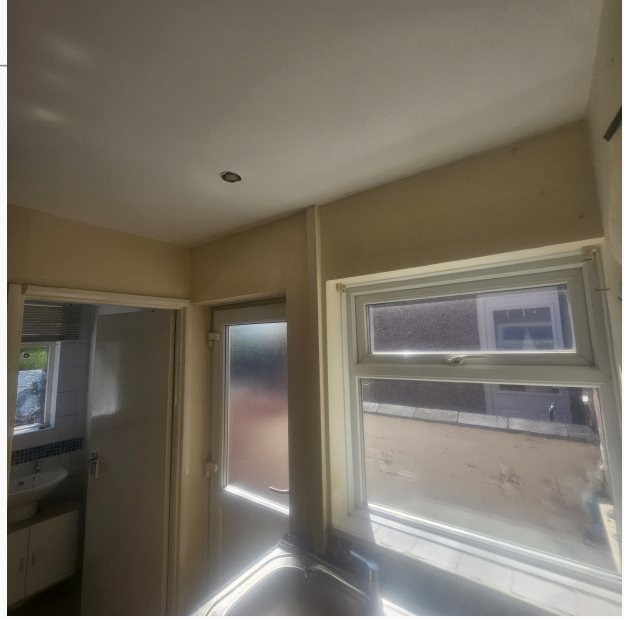
Photos

Upon inspection, there is evidence of water ingress to the front window area, likely due to defective brickwork and pointing. This is allowing moisture to penetrate internally and contribute to the damp conditions observed.

Internally, the property is in overall need of general redecoration, with visible staining, marks and areas affected by mould growth. The mould present appears to be a combination of the external ingress noted and internal environmental factors, including insufficient heating and limited use of windows for ventilation.

The bathroom extractor fan is operational and considered adequate. However, the kitchen lacks sufficient mechanical ventilation, which will contribute to elevated moisture levels within the property. In addition, the bathroom window is of an older specification and not performing efficiently; replacement is recommended to improve thermal performance and reduce condensation.

Repointing to the external brickwork surrounding the front window to prevent further water ingress.

Improvement of ventilation to the kitchen area, subject to specification, to better manage internal humidity levels.

Replacement of the existing bathroom window with a new unit to improve insulation and reduce condensation risk.

Carry out full internal preparation and redecoration throughout the property, including treatment of affected mould areas, application of appropriate stain block products, and repainting to provide a clean and uniform finish.

Addressing the external defect is essential prior to or in conjunction with internal works, as failure to do so will result in ongoing moisture ingress and recurrence of the issues.
