Inhome Property Solutions

# Property Survey

26 Highland Way Redditch B98 7RH

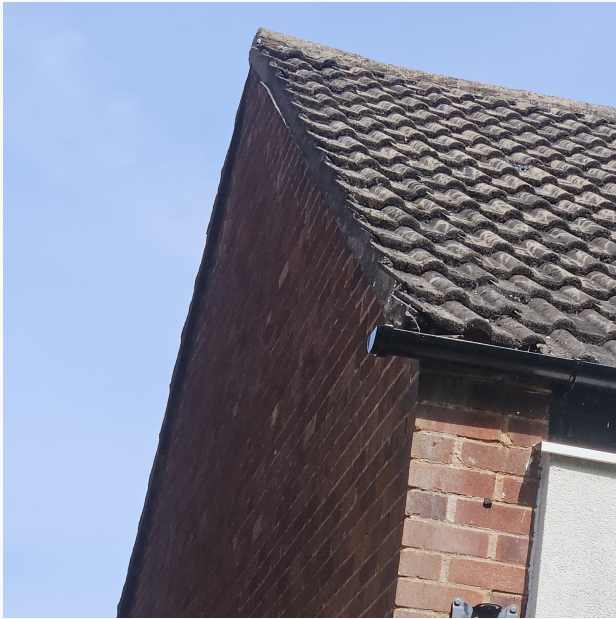
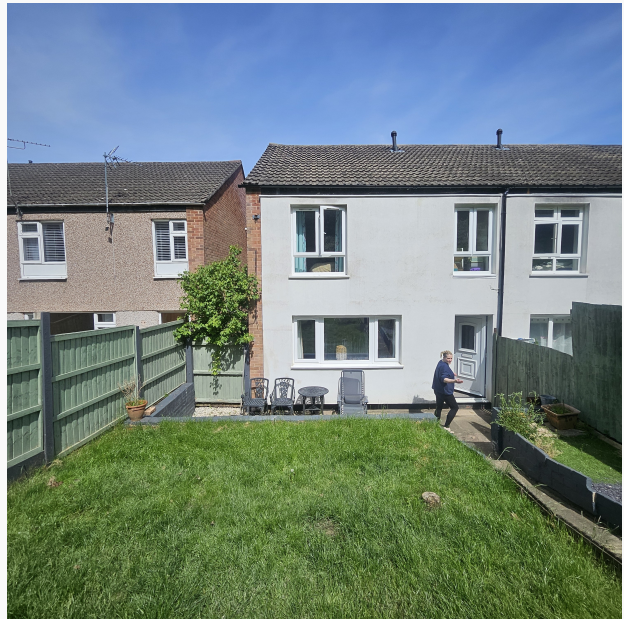
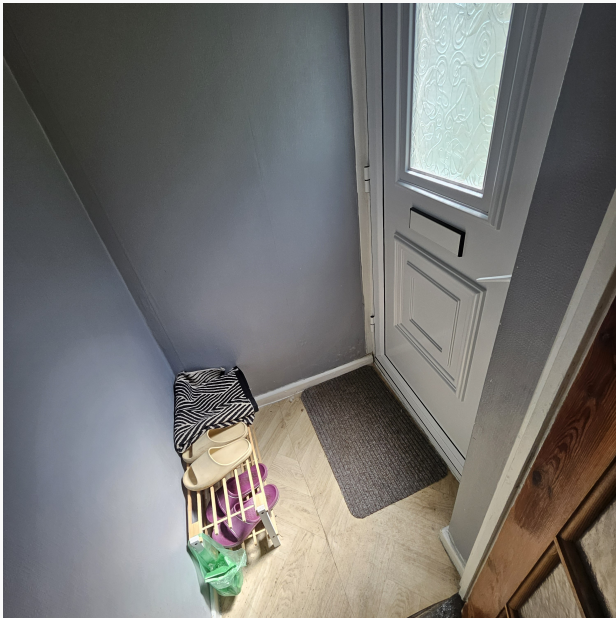
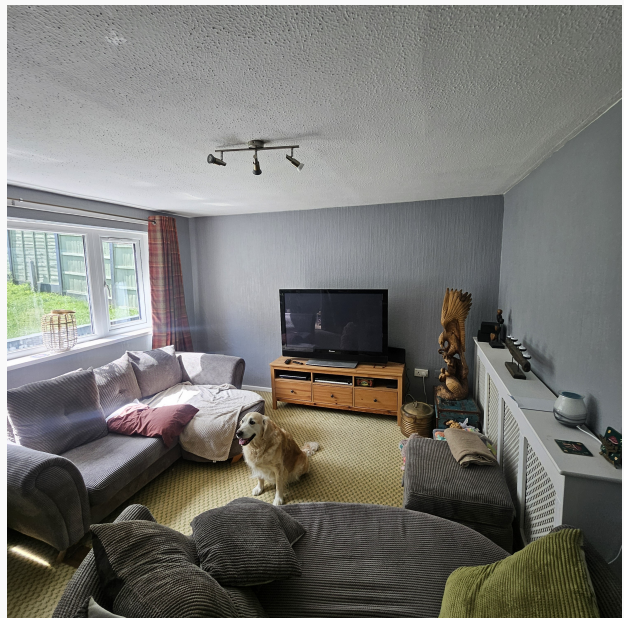
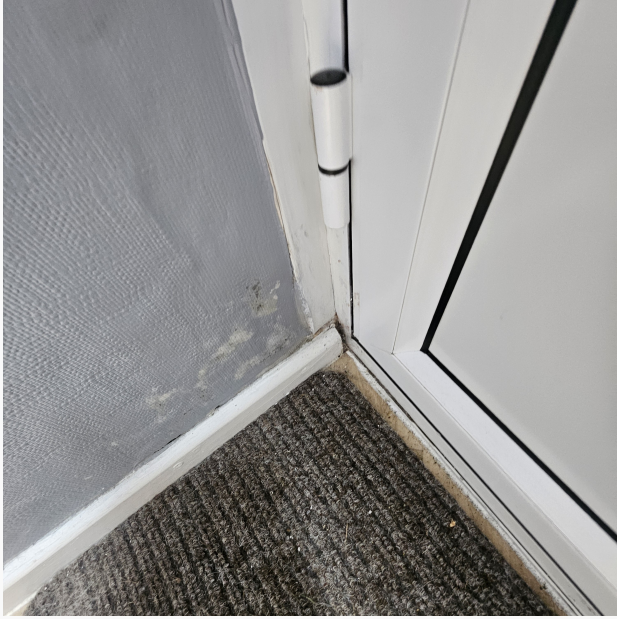
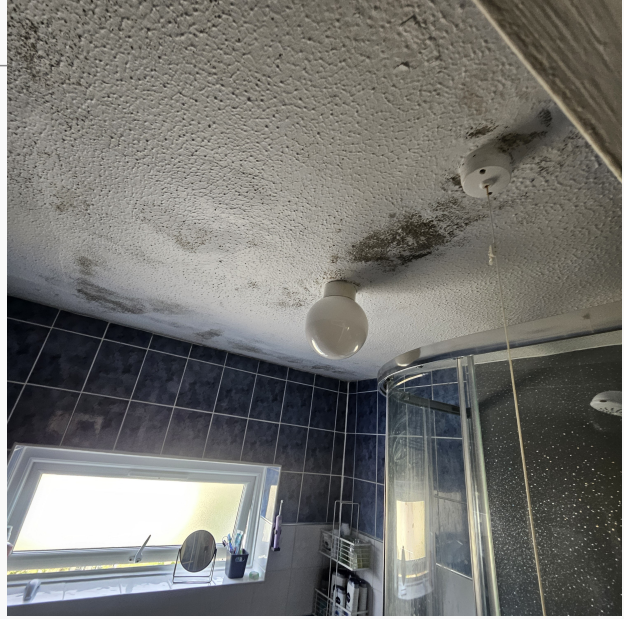
# Photos

During the external roof inspection, we identified multiple defects contributing to water ingress. A large section of mortar is missing from the verge, there is a lifted ridge tile at high level, and the front guttering system is defective and allowing water to discharge incorrectly rather than flow away as intended. The roof covering itself is extremely old and includes non-breathable felt, which restricts proper airflow within the roof structure. Due to these defects, water is penetrating the property and running down through the cavity areas, which is contributing towards the mould growth visible internally, particularly within the living room areas.

Internally, visible mould growth was identified within the bathroom ceiling area. Upon inspection, there is currently no extraction or mechanical ventilation installed within the bathroom whatsoever. Under current Building Regulations Part F guidance, rental properties should have adequate ventilation installed to control humidity and condensation. Due to the lack of extraction, moisture and humid air cannot escape the property correctly, resulting in excessive condensation and mould formation.

The recommended remedial works would be to erect scaffolding to the property in order to carry out the roofing works safely. We would recommend installing a new dry verge system to improve weather protection and ventilation, rebedding the lifted ridge tile, and replacing the defective front guttering system.

In relation to the bathroom ventilation, we would recommend a qualified electrician installs a new humidistat-controlled extraction fan, vented directly externally from the property. This is the most effective method of controlling moisture, humidity, and condensation within the bathroom environment.

Once the source of water ingress and condensation issues have been rectified, internal mould remediation works can then be carried out. These works would include cleaning and treating affected areas with specialist anti-fungal treatments. Any wallpaper affected by mould contamination would need to be removed, as mould spores penetrate wallpaper surfaces and cannot be permanently cleaned or treated effectively once infected. Further redecoration works can then be carried out once the affected areas are fully dry and stable.
