Property Survey

Room 6 20 Lee Road Leamington Spa CV31 3JQ

Damp & Mould Report

Property Inspection Report

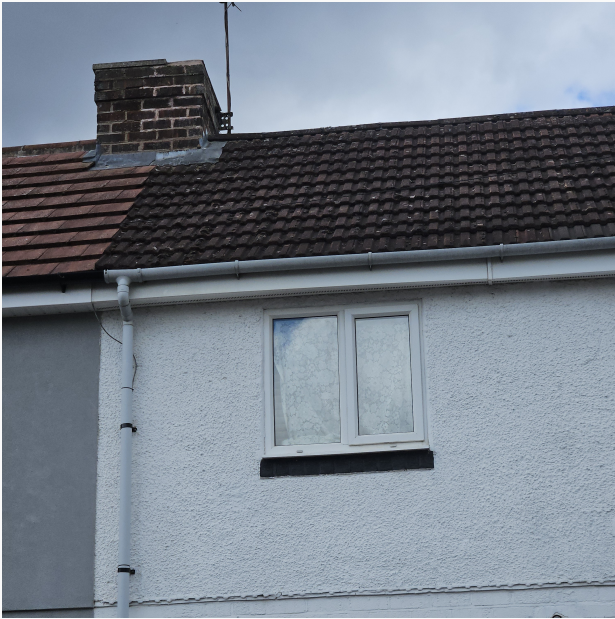
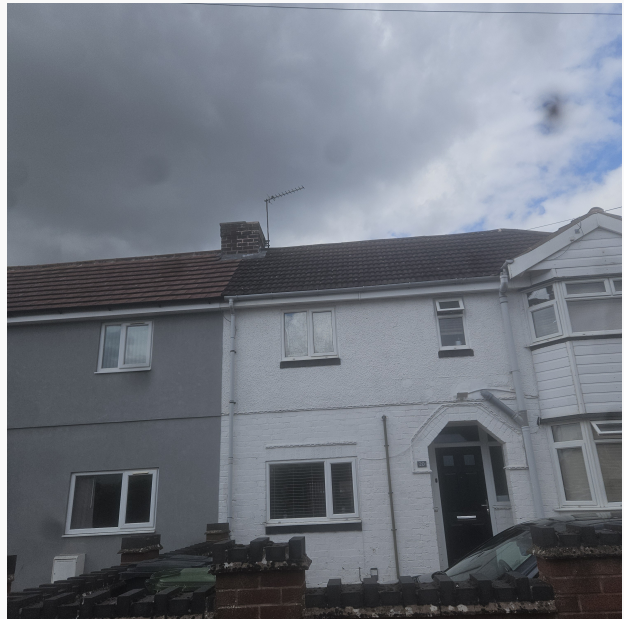
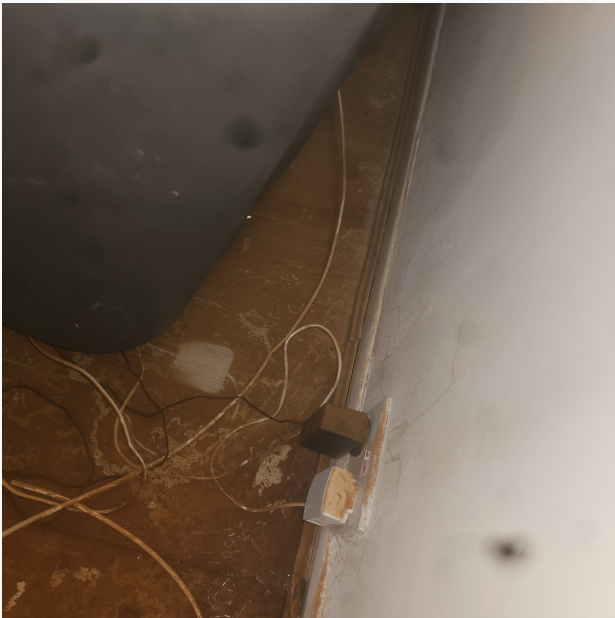
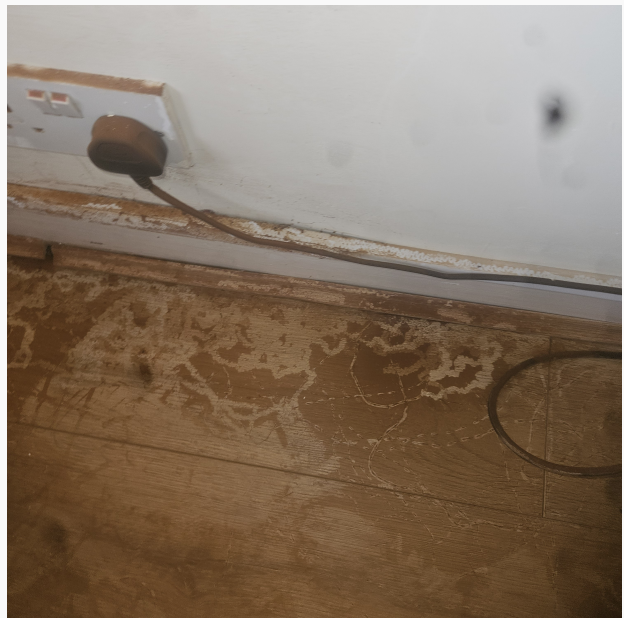
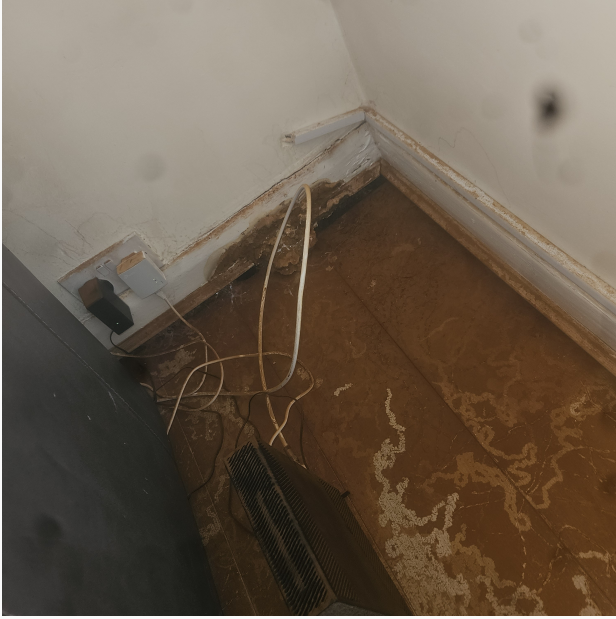
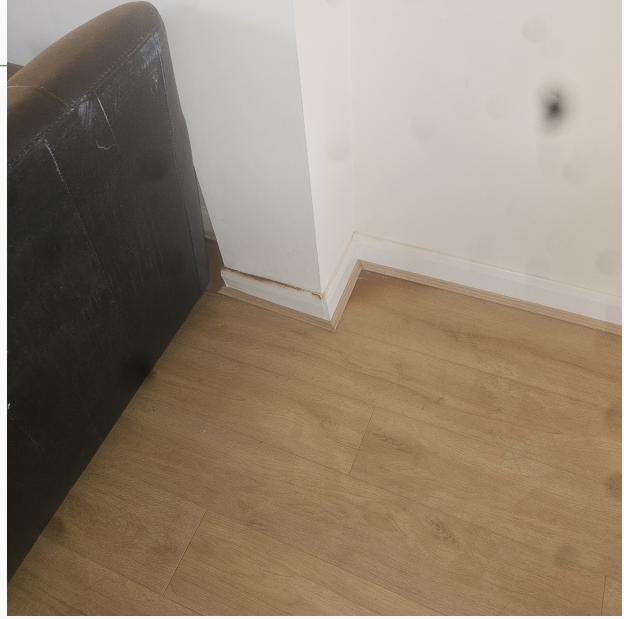
Photos

During our inspection, we found significant moisture damage to the flooring within the front reception room.

The existing floor has extensively deteriorated and is no longer structurally suitable. At present, a sheet of plywood has been laid over the damaged area and is being used as the finished floor. On inspection, the subfloor beneath is damp, deteriorated and showing signs of rot. The presence of mushrooms is consistent with prolonged moisture exposure and indicates that the timber has been subjected to sustained damp conditions.

An external inspection of the roof was also carried out. It is evident that roofing works have been undertaken at some point in the past. However, without knowing the property's repair history, it is not possible to determine whether the damage has resulted from historic roof leaks, previous flooding or another source of water ingress that has since been rectified.

At the time of our inspection, we did not identify any obvious signs of an active roof leak. Based on our observations, we do not believe there is an ongoing roof defect causing the current condition. However, this cannot be guaranteed without further invasive investigations should new signs of water ingress appear.

Lift and dispose of all existing flooring throughout the front reception room and adjoining lounge.

Remove all damaged and rotten subfloor timbers where required.

Allow the affected areas to dry thoroughly before any reinstatement works commence.

Supply and install new structural subflooring where required.

Supply and fit new finished floor coverings throughout the affected areas.
